# Water Mitigation Report

April 16, 2025

## Summary

Water source: refrigerator supply line.

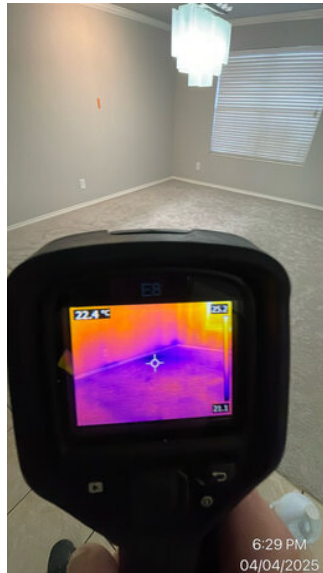
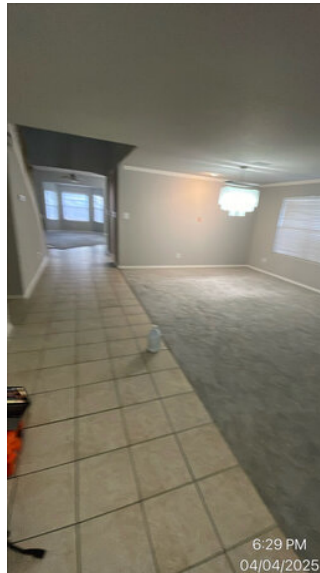
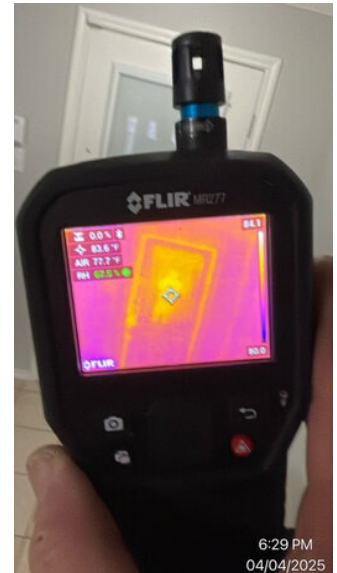
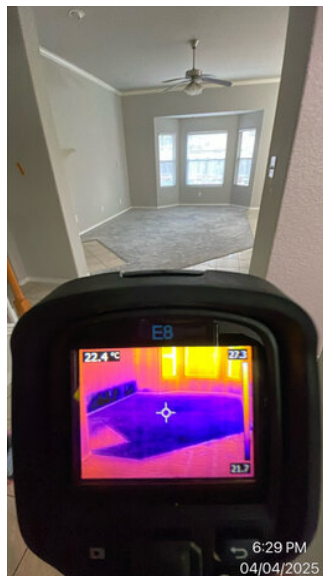
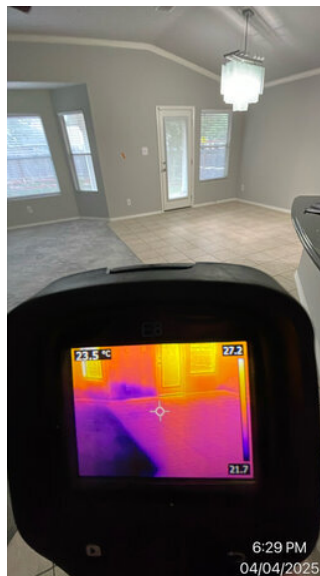
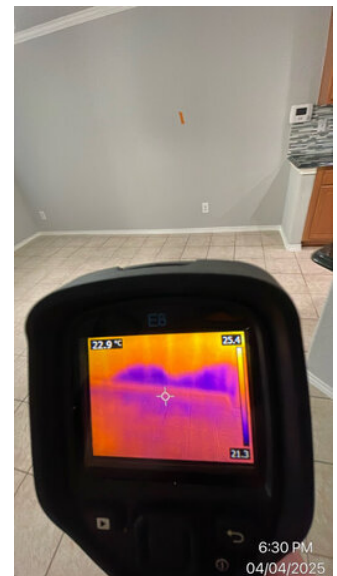
Water damage to the walls and carpet, baseboards and majority of the downstairs, including kitchen cabinets all the way into the master bathroom, utility room, master bedroom, stairway, kitchen, living room, pantry den garage hall bath under stairs, closet.

Used Flir MR77 MR277 and Infrared E8 for moisture mapping

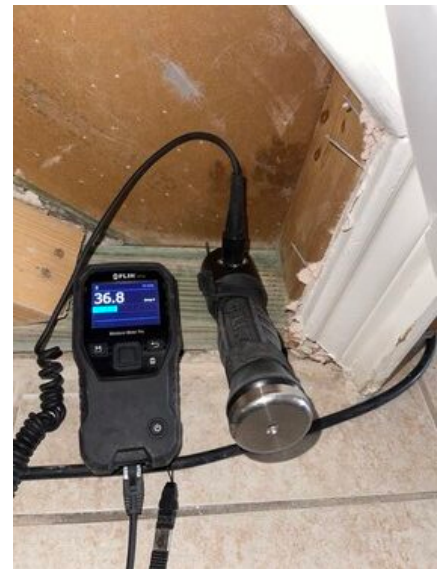
| Notes | Temp | RH | GPP |
|---|---|---|---|
| I was taking my measurements. I took note of the stairway area. Within the house, there was still a And they were staining Stairway wall trim I took a Moisture measurement of 40+ percent I realize it was MDF is not solid wood, which means it needed to come out due to the staining and the moisture content that was in it in the swelling. | 94 °F | 31% | 76.01 |

| Notes | Temp | RH | GPP |
|---|---|---|---|
| To do this min disassembling all of the trim areas working to try to not damage anything that was not already damaged at the end of the day it means that It will need to be redone all the way up to the second floor. Uploaded photos | | | |
