# Water Mitigation Report

April 16, 2025

## Summary

Water source: refrigerator supply line.

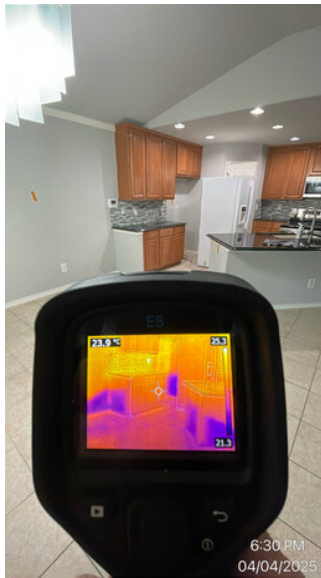
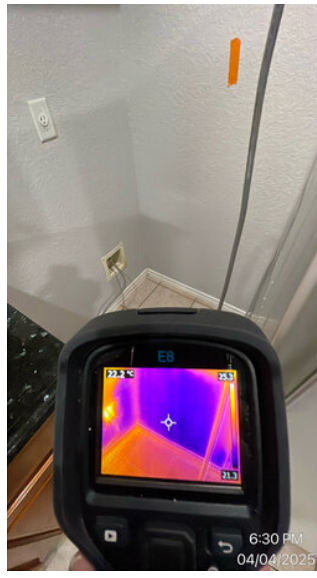
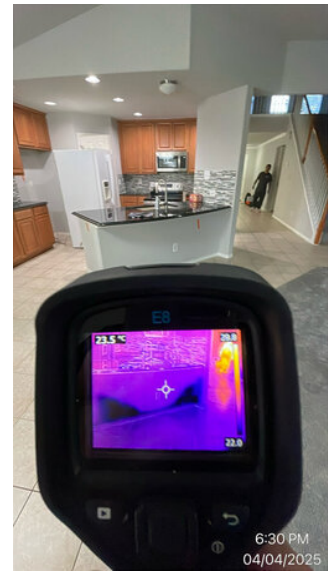
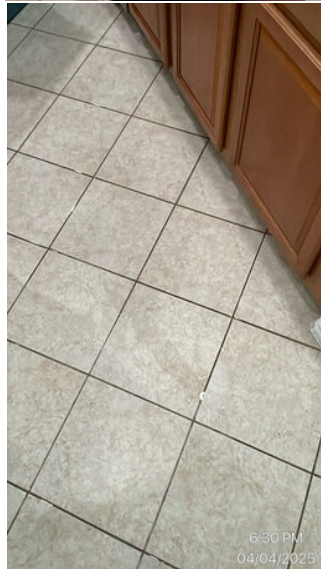
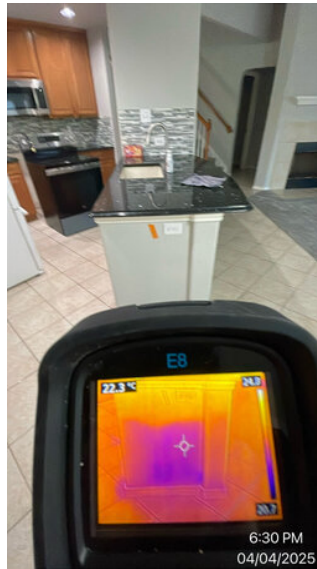
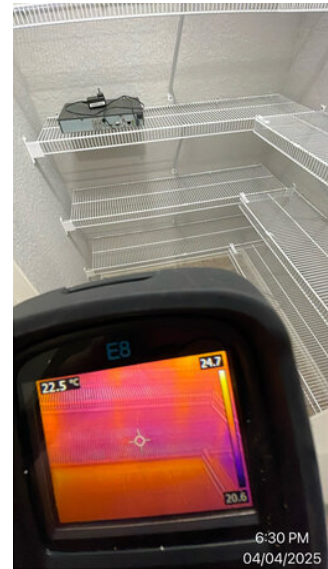
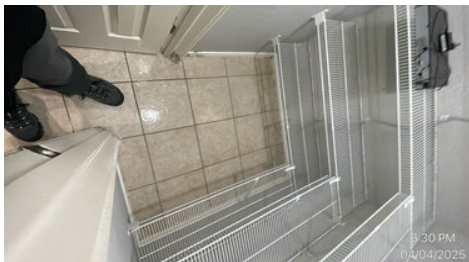
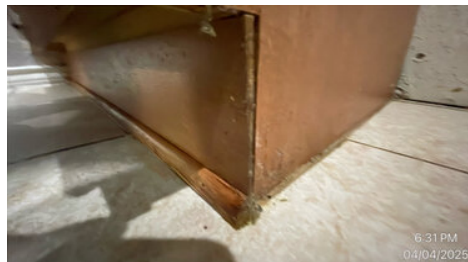
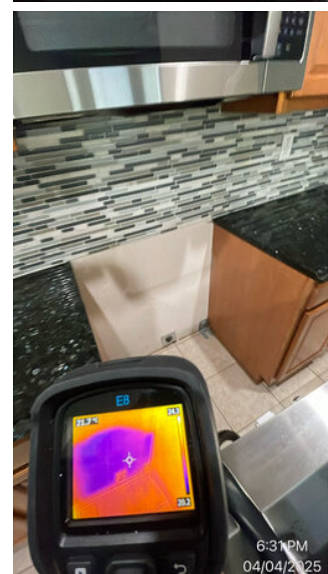
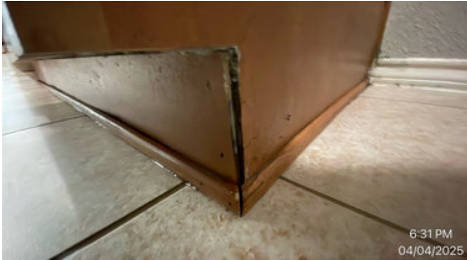
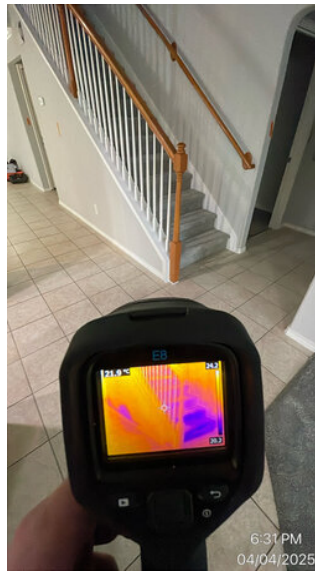
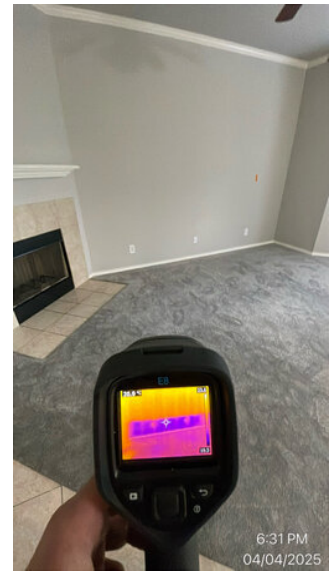
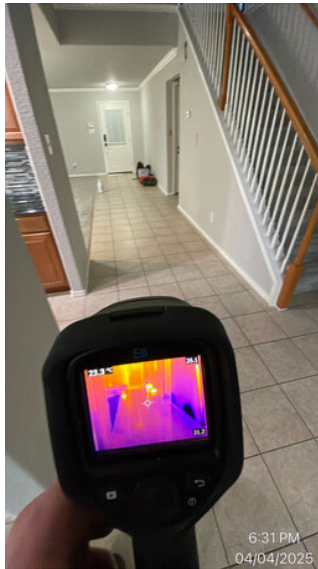
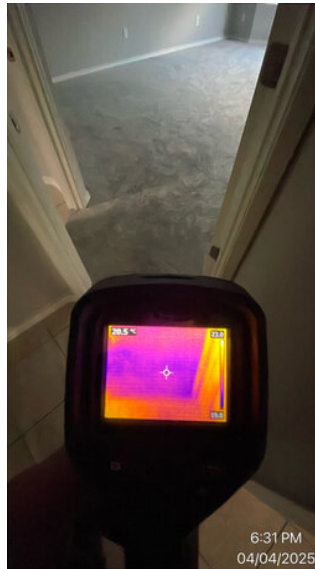
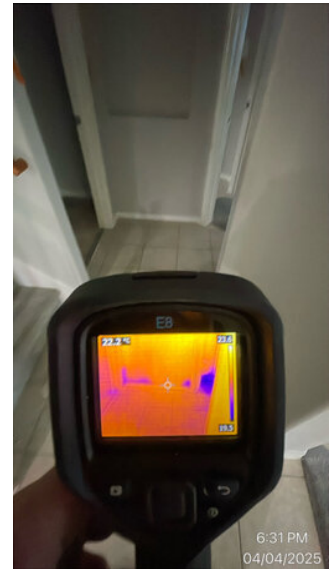
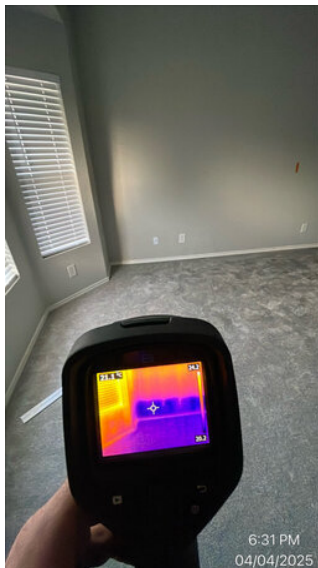
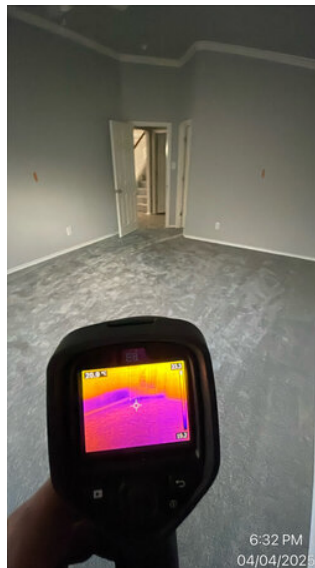
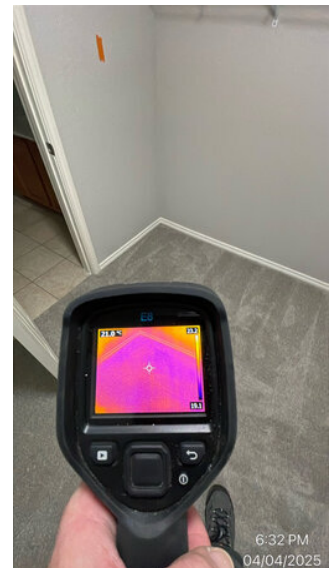
Water damage to the walls and carpet, baseboards and majority of the downstairs, including kitchen cabinets all the way into the master bathroom, utility room, master bedroom, stairway, kitchen, living room, pantry den garage hall bath under stairs, closet.

Used Flir MR77 MR277 and Infrared E8 for moisture mapping

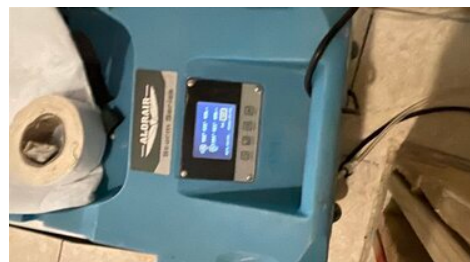
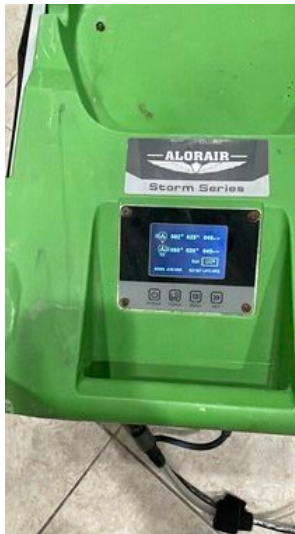
D-006

Need to check the Dining room dehumidifier sensor its working properly, but the readings on the displayer off I took the readings are off and showing 122° and 12% output I checked it with my meter I recorded the readings off of MR277 Meter

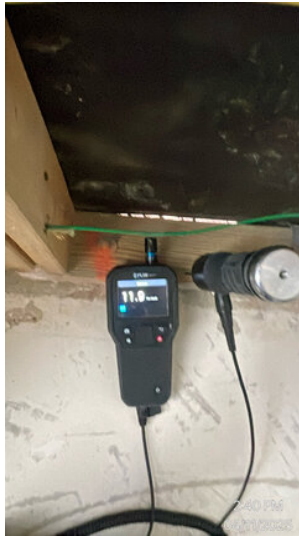
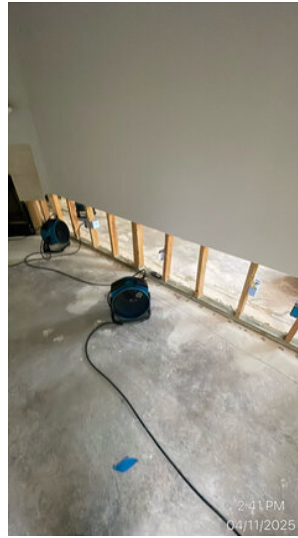
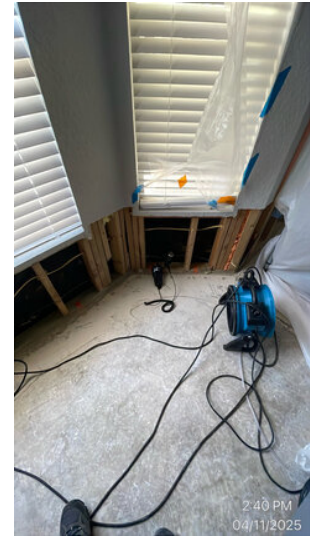
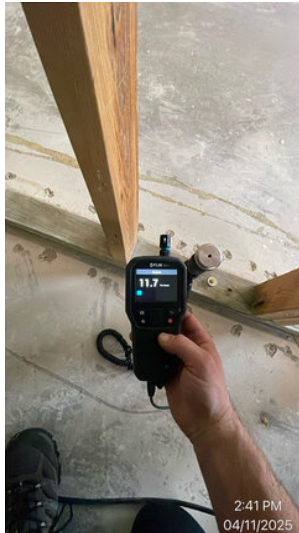
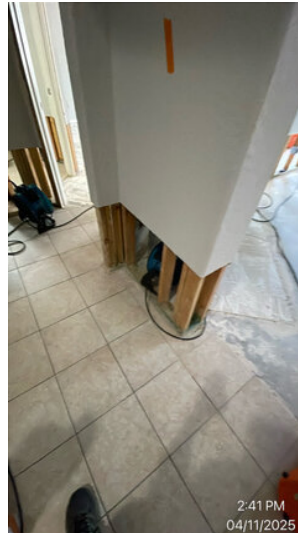
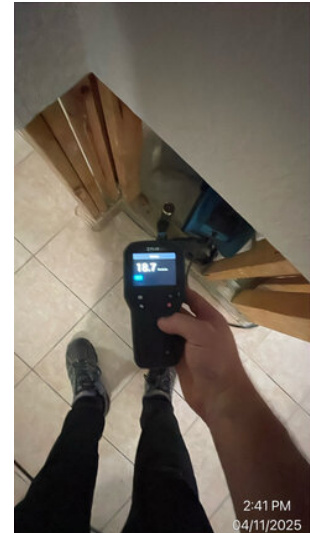
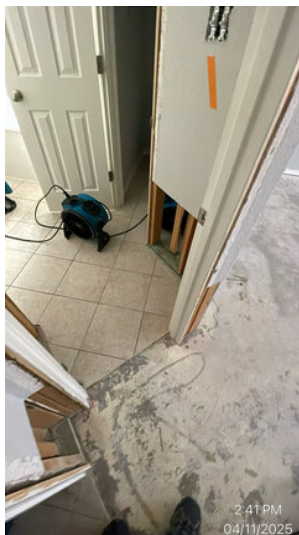
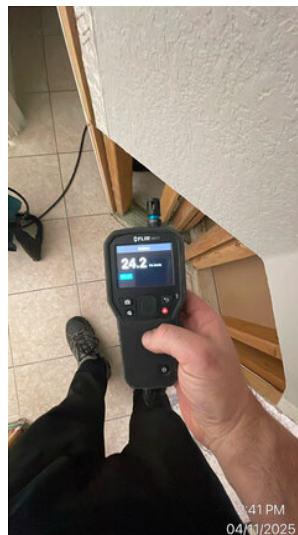
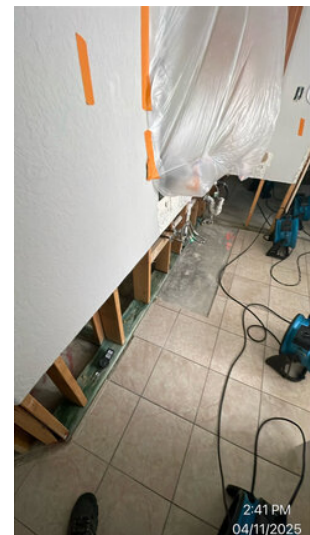
| Notes | Temp | RH | GPP |
|---|---|---|---|
| I was taking my measurements. I took note of the stairway area. Within the house, there was still a And they were staining Stairway wall trim I took a Moisture measurement of 40+ percent I realize it was MDF is not solid wood, which means it needed to come out due to the staining and the moisture content that was in it in the swelling. | 94 °F | 31% | 76.01 |

| Notes | Temp | RH | GPP |
|---|---|---|---|
| To do this min disassembling all of the trim areas working to try to not damage anything that was not already damaged at the end of the day it means that It will need to be redone all the way up to the second floor. Uploaded photos | | | |
